# **Captive Wildlife Report**

#### Narrative: COMPLAINT INSPECTION

Narrative Date/Time	Narrative Synopsis			
	12/31/2021 11:33:56 AM	NAPLES ZOO TIGER INCIDENT			
Rep	porting Officer		Officer Rank	Officer ID No	Officer Org/Unit
KL	EIS, KEVIN		INVESTIGAT	WN765	FWCS\SO REGION B\COLLIER INVEST
Of	ficer Signature	Kñ	Officer Agency FLORIDA FISH COMMISSION	AND WILDLIFE	CONSERVATION
0		L. Inconstitution Marsha Maria	af the a Ellawish a	Einle nund M	/:   :£

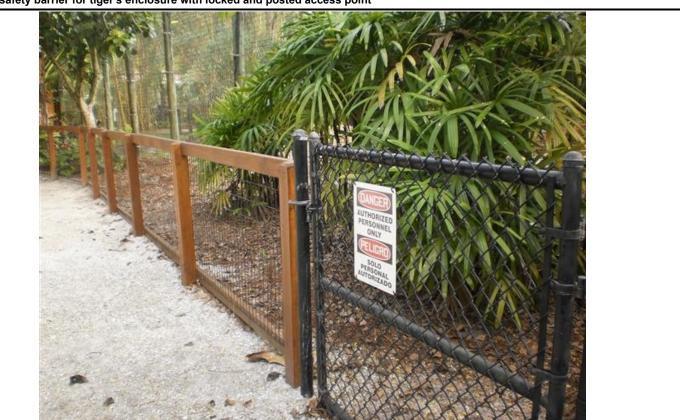
Structural safety barrier for tiger's enclosure with locked and posted access point

required. The tiger's enclosure is equipped with a structural safety barrier to prevent unauthorized access to the tiger's enclosure. The structural safety barrier is posted with a sign stating, "DANGER AUTHORIZED PERSONNEL ONLY". The tiger's enclosure is open top with 13-foot-high walls made of 7-gauge steel welded wire with a 5-foot, 45-degree, inward angle overhang. The connecting material used is made of 9-gauge steel wire. FWC Inv. D. Fowler used a Faro 3D laser scan to document the scene and the tiger's enclosure.

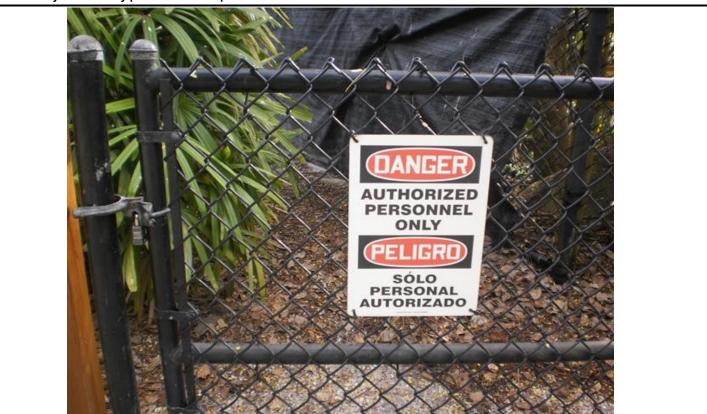
Structural safety barrier entry point locked and posted "DANGER AUTHORIZED PERSONNEL ONLY"

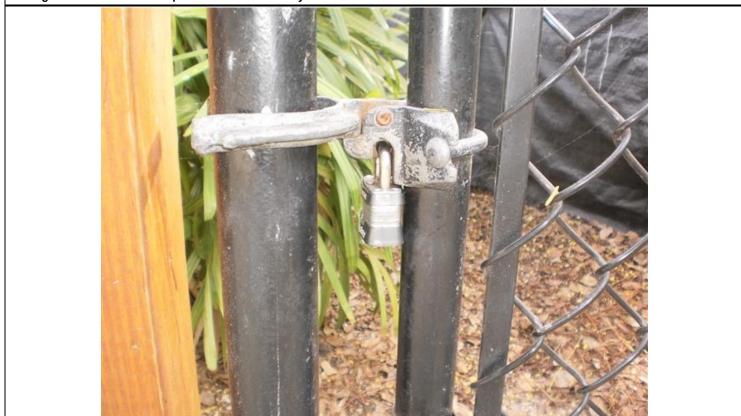
Locking mechanism for access point on structural safety barrier

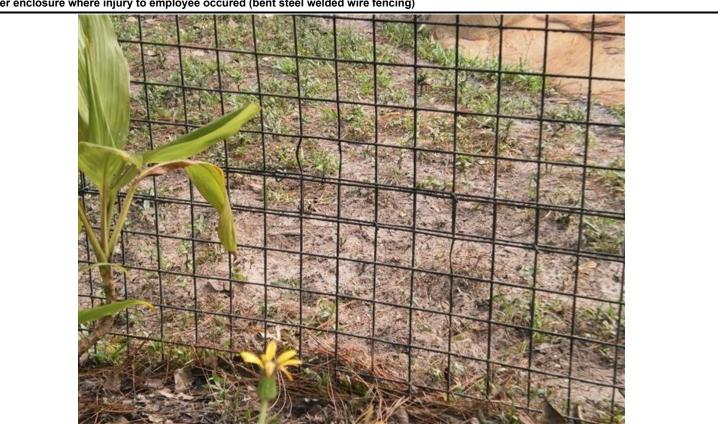
Tiger enclosure where injury to employee occured (bent steel welded wire fencing)

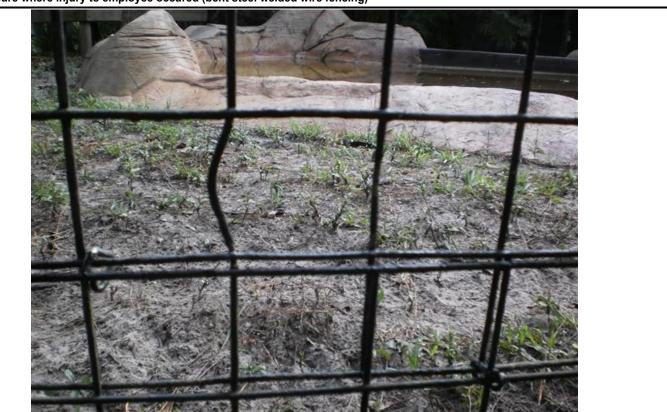
Tiger enclosure where injury to employee occured (bent steel welded wire fencing)

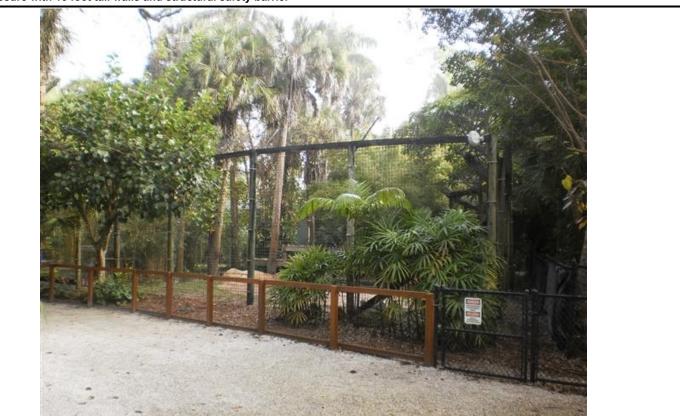
Tiger enclosure with 13 foot tall walls and structural safety barrier

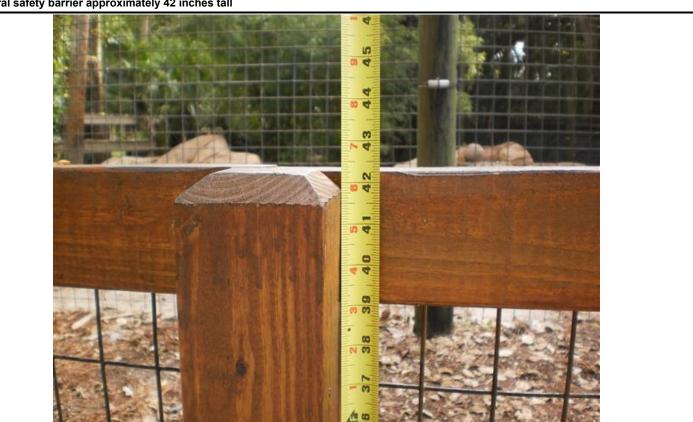
Sturctural safety barrier approximately 42 inches tall

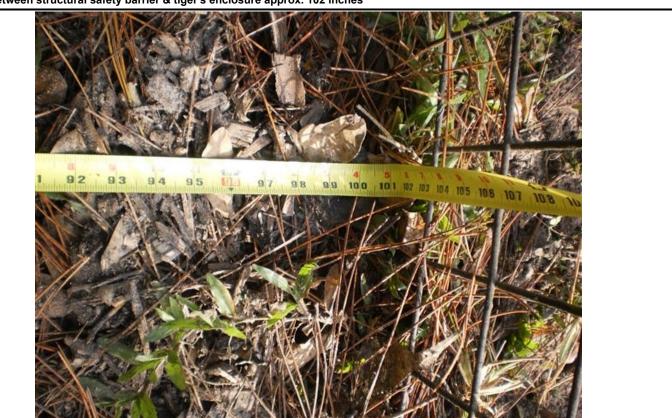
Distance between structural safety barrier & tiger's enclosure approx. 102 inches

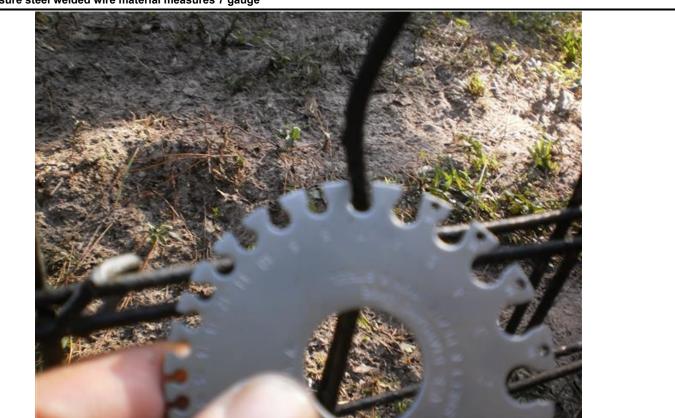
Tiger enclosure steel welded wire material measures 7 gauge

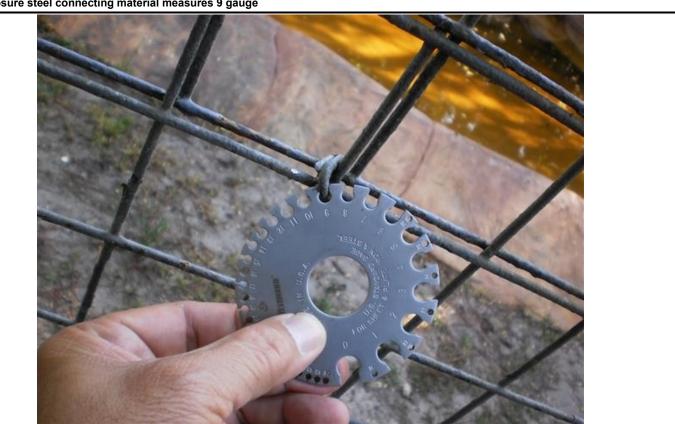
Tiger enclosure steel connecting material measures 9 gauge

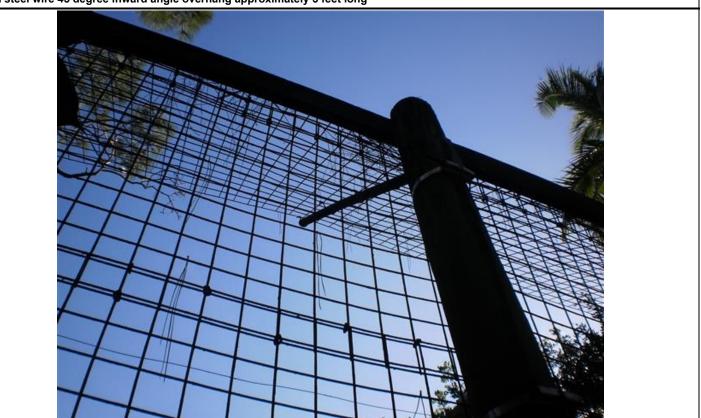
Welded steel wire 45 degree inward angle overhang approximately 5 feet long

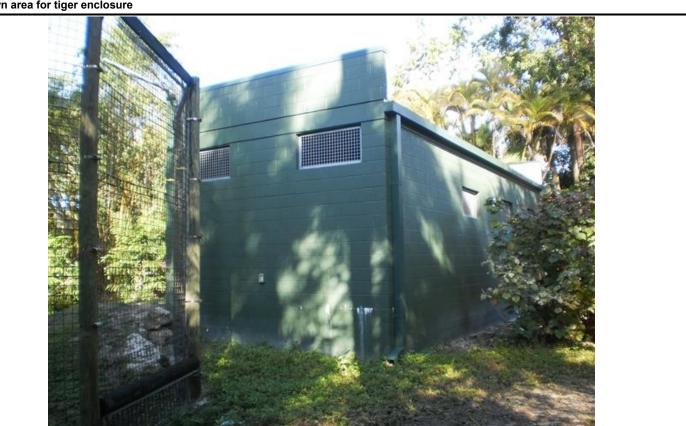
Lockdown area for tiger enclosure

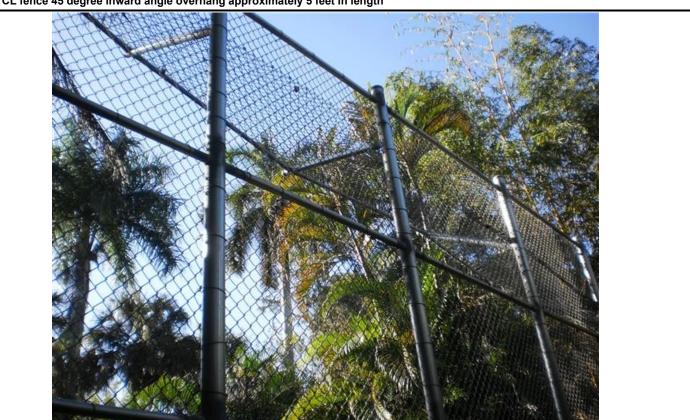
9 gauge CL fence 45 degree inward angle overhang approximately 5 feet in length

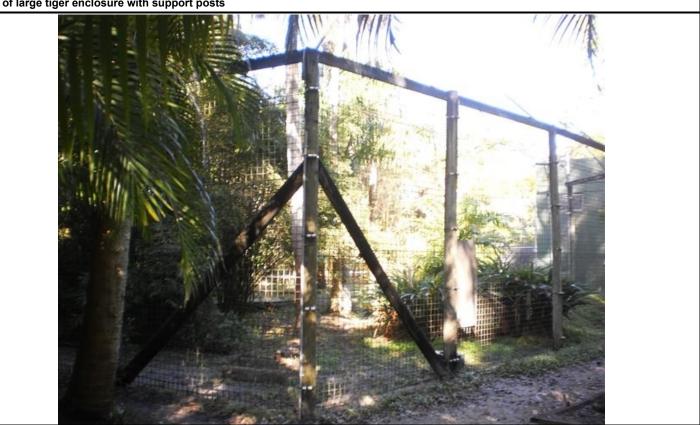
Corner of large tiger enclosure with support posts

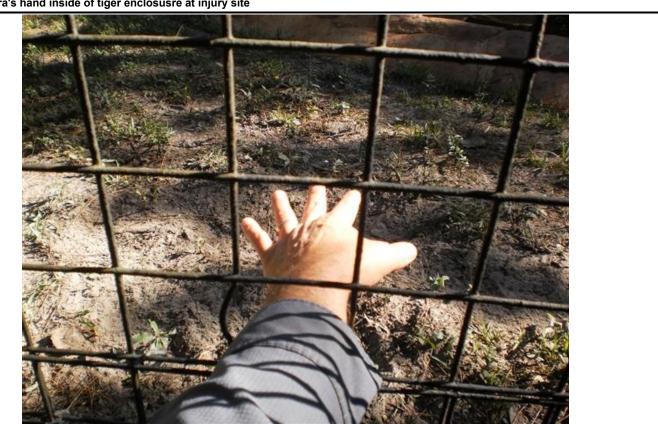
Inv. Corteguera's hand inside of tiger enclosusre at injury site

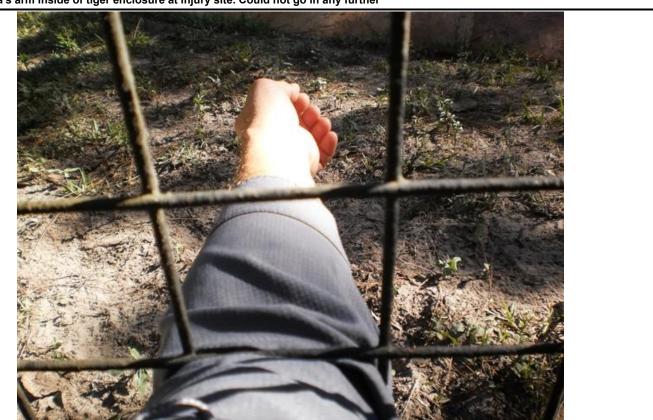
Inv. Corteguera's arm inside of tiger enclosure at injury site. Could not go in any further

At the conclusion of my investigation, I found no violations as it relates to the Naples Zoo. Mr. Rosenquist had to have breached the posted structural safety barrier by jumping over it and inserting his hand or arm into the tiger's enclosure, leading to this incident. Structural safety barriers are designed to keep unauthorized persons from getting within close proximity to dangerous wildlife enclosures for safety reasons. I used my agency issued body camera and picture camera for

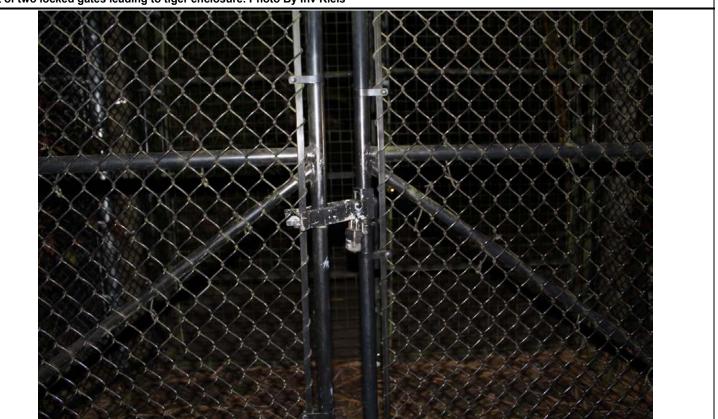
First of two locked gates leading to tiger enclosure. Photo By Inv Kleis

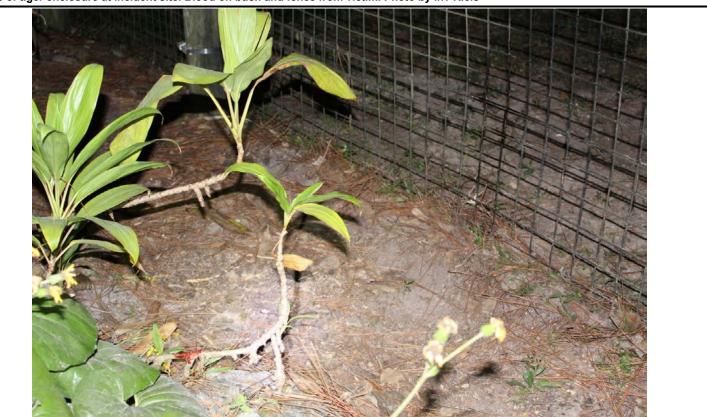
Fence of tiger enclosure at incident site. Blood on bush and fence from victim. Photo by Inv Kleis
